**Interpreting Site Formation Processes Affecting Re-emergent Cultural Sites within  
Reservoirs: A Case Study of St. Thomas, Nevada.**

**Master of Arts  
in  
Geography**

**Department of Geology and Geography**

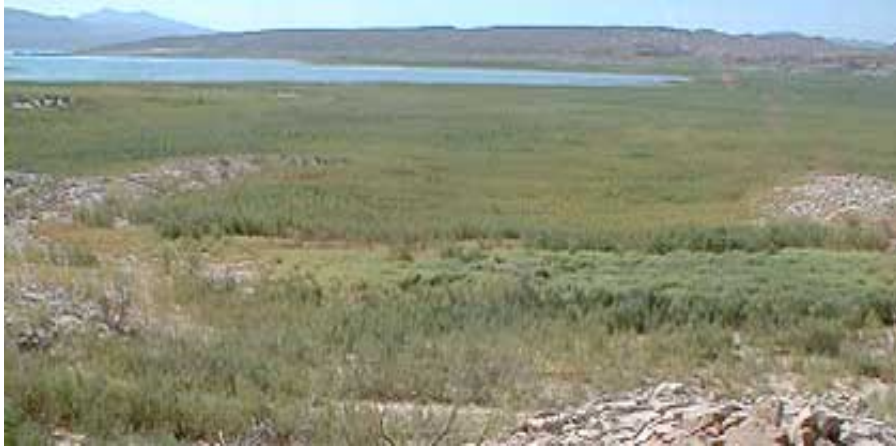
Figure 6: St. Thomas Point overlooking St. Thomas and Lake Mead. Photo taken May 2006.

Field investigations conducted in January 2006 concentrated on discerning the processes at work that distributed sediment at St. Thomas, conducting assessments on the conditions of the remaining structures and the analysis of historic 1925 aerial photography of St. Thomas on reserve at Whittier College. Soil probes were placed in areas where sediments remain, using an Oakfield soil probe with a diameter of 2.9 cm and beginning in the foreshore area (approximately 3 m from the present shoreline) and moving in a southwesterly direction toward St. Thomas Point (Figure 6).

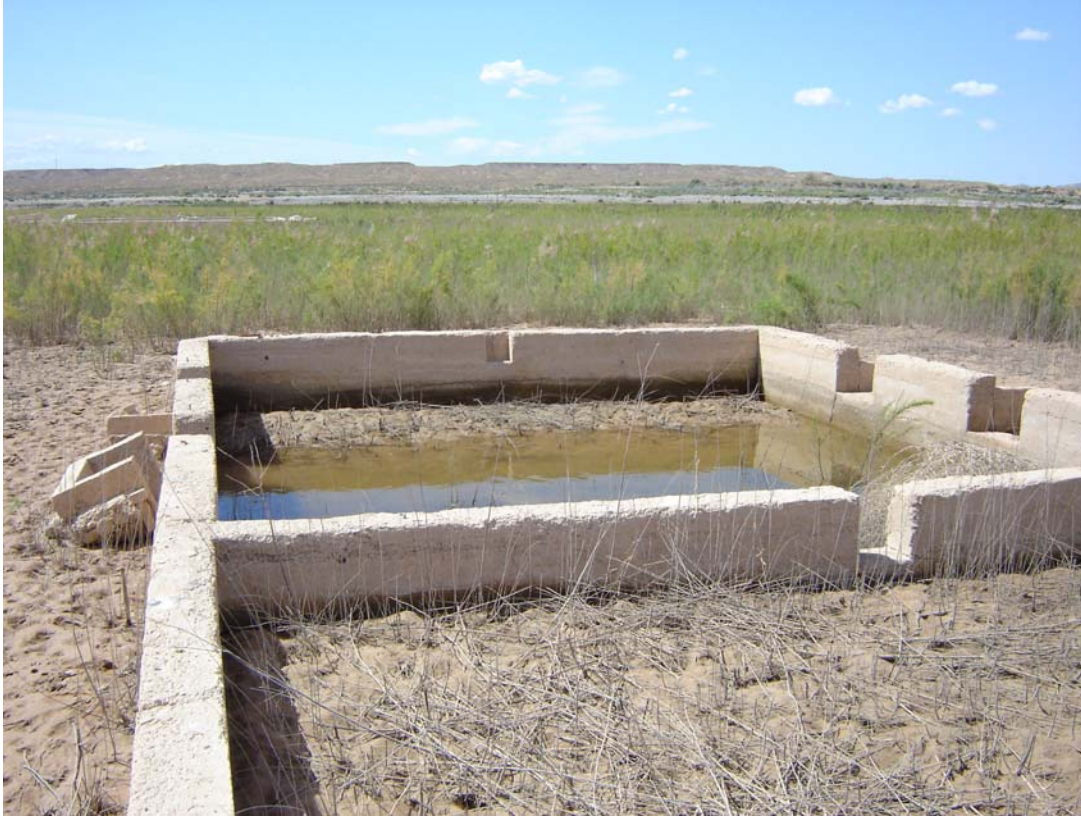
Figure 7: Re-emerged walls and remnants of the blacksmith shop at St.Thomas. Note sediment accumulation within the structure. Photo taken May 2005.

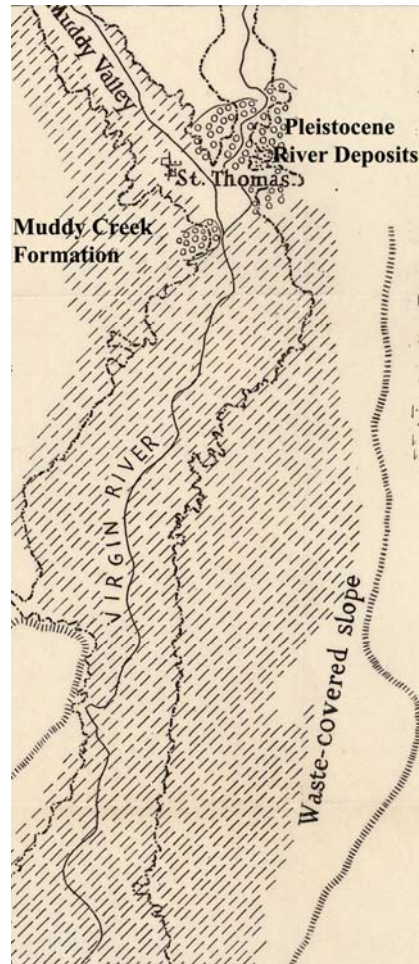
Figure 8: Geology of the Overton Arm. Dashed lines symbolizes Muddy Creek Formation and open dots symbolize Pleistocene river deposits. Modified from: Longwell, 1936.

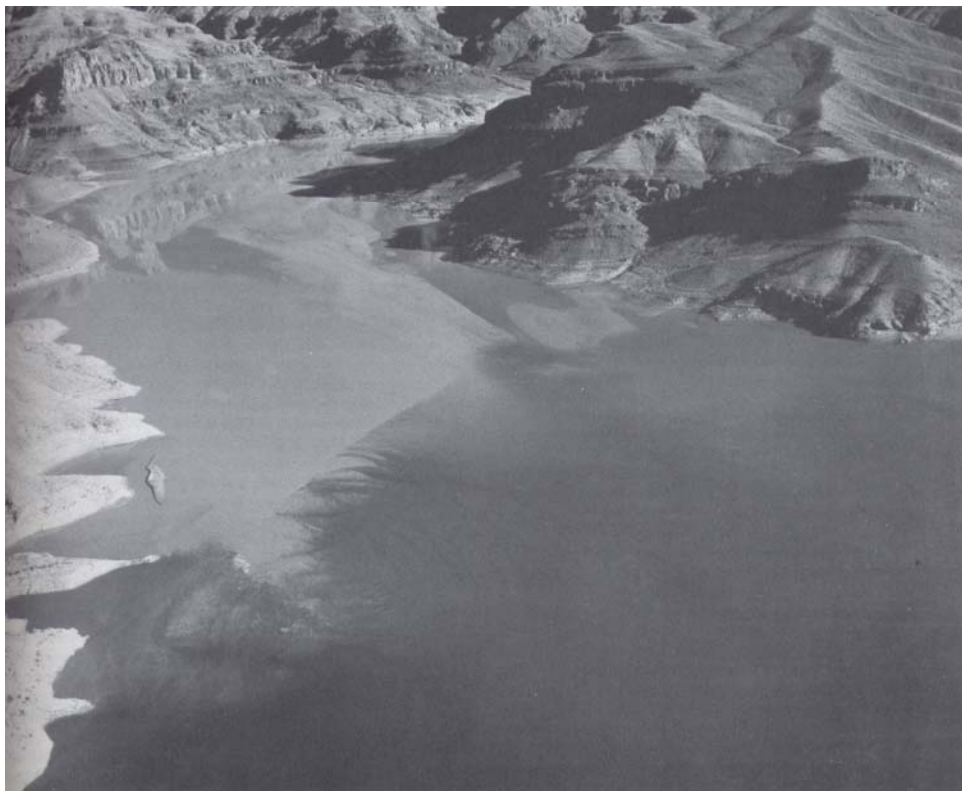
Figure 9: Convergence of Colorado River and Lake Mead in Pierce Basin. Note sharp contrast between relatively clear lake water and turbid river water that rushes down to the lake bottom; this illustrates how density currents operate. Photo source: Howard, 1948.

Suspended sediments derived from Colorado, Virgin, and Muddy rivers and tributary streams, and entering Lake Mead (Figure 9) depend on reservoir hydraulics for dispersion. Density currents operate as a gravity flow of fluid through, under, or over a fluid of approximately higher or lower density with little mixing occurring between the two fluids (Figure 9) (Howard, 1948). Density currents derived from the Colorado River are responsible for transporting sediments that enter the reservoir in eastern Pierce basin and extend throughout the entire reservoir. Density currents flowing through

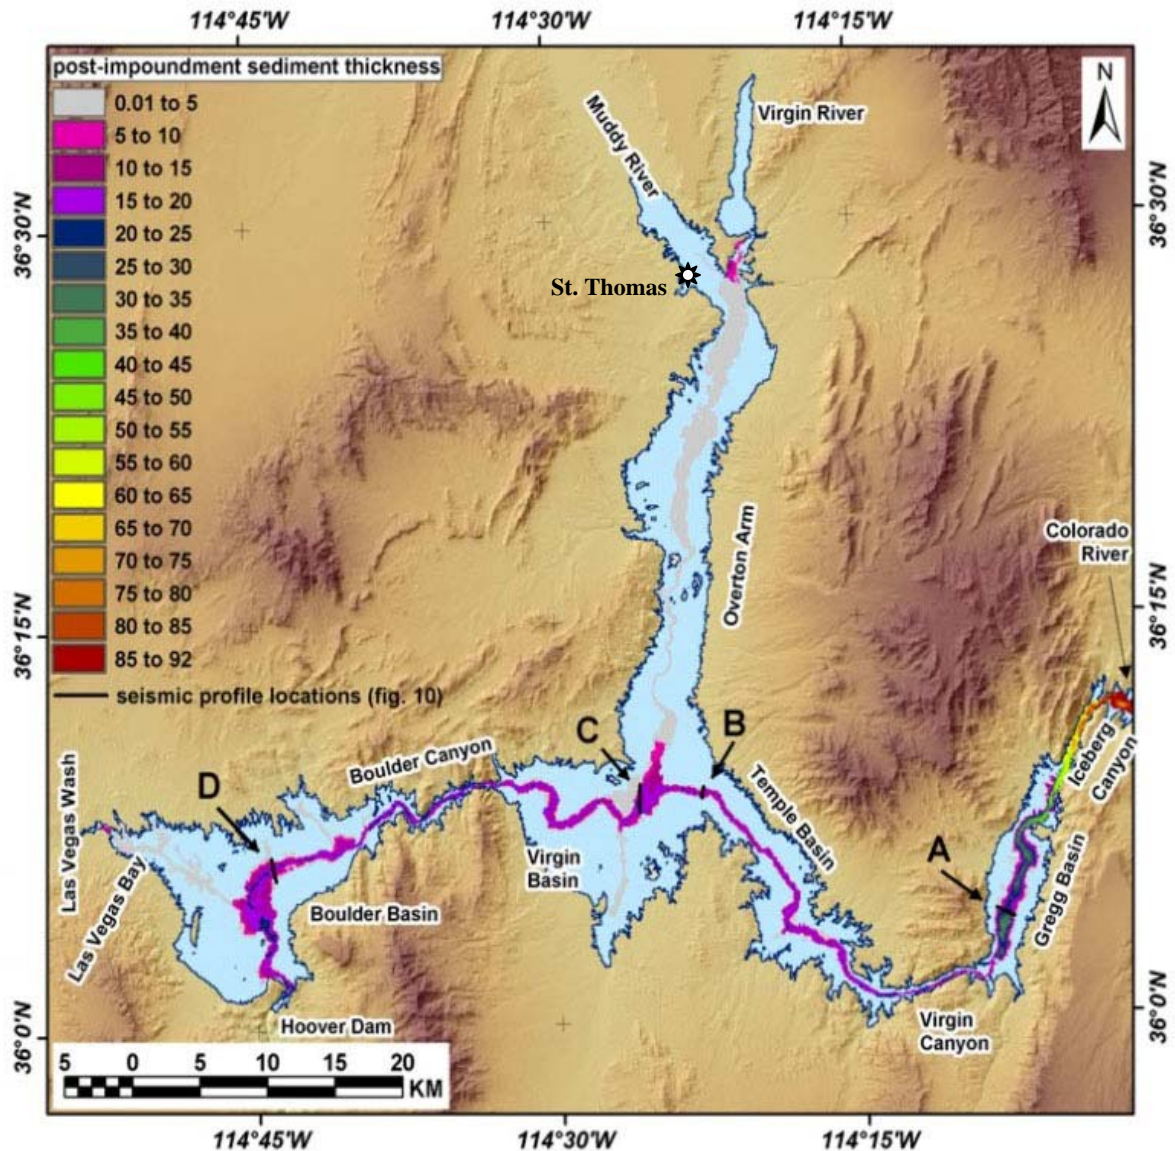
Figure 10: Map of the thickness of post-impoundment sediment in Lake Mead. Light blue indicates lake area. These sediments have accumulated since completion of the Hoover Dam in 1935. Modified from: Twichell et al., 2003.

Sidescan sonar and high-resolution seismic data acquired during the 2001 Woods Hole (Twichell et al., 2003) survey of the Virgin Basin and Overton Arm of Lake Mead allowed mapping of the post-impoundment sediments to determine the thickness of accumulation within each basin (figure 10). Sediment accumulation is sparse in the Overton Arm and in the area surrounding St. Thomas, but deposition is apparent in the remnant Muddy channel.

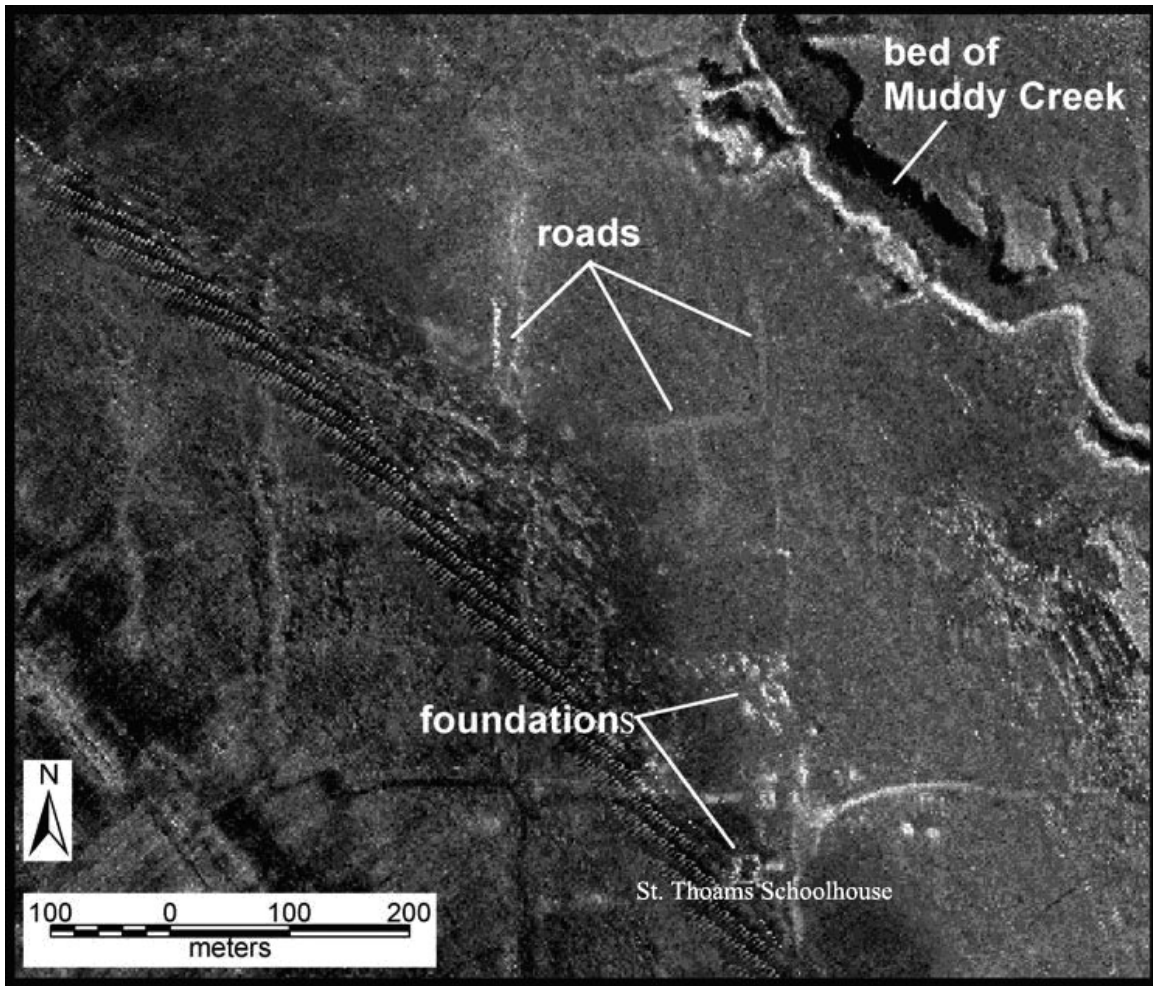
Figure 11: Sidescan-sonar image of the town of St. Thomas, which was submerged shortly after Lake Mead started to fill. Streets trend north-south and east-west and some of the high-reflectance targets are foundations. Modified from: Twichell et al., 2003.

Side-scan imagery does reveal other areas of sediment accumulation within St. Thomas (Figure 11). This image depicts several remaining roads and foundations and the largest foundation located in the southeastern corner is the St. Thomas schoolhouse. In contrast to other foundations, which give a high acoustic backscatter and appear white, the interior of the schoolhouse foundation is a distinct dark grey similar to the reflectance

from the post-depositional sediments in the former bed of the Muddy River, and giving a clue that walled structures such as the schoolhouse are possible sediment traps.

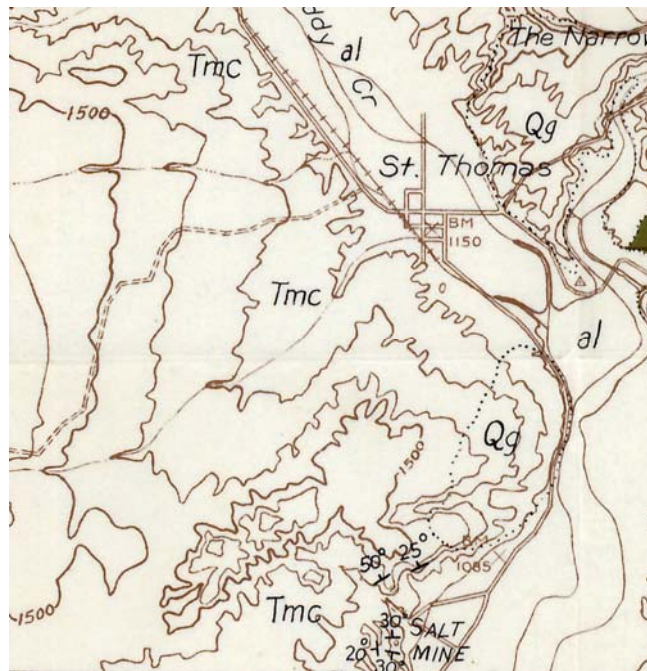
Figure 12: Bench mark on 1932 topographic map indicates surface elevation at St. Thomas as 1150 ft (~350 m). Map from: Longwell, 1932.

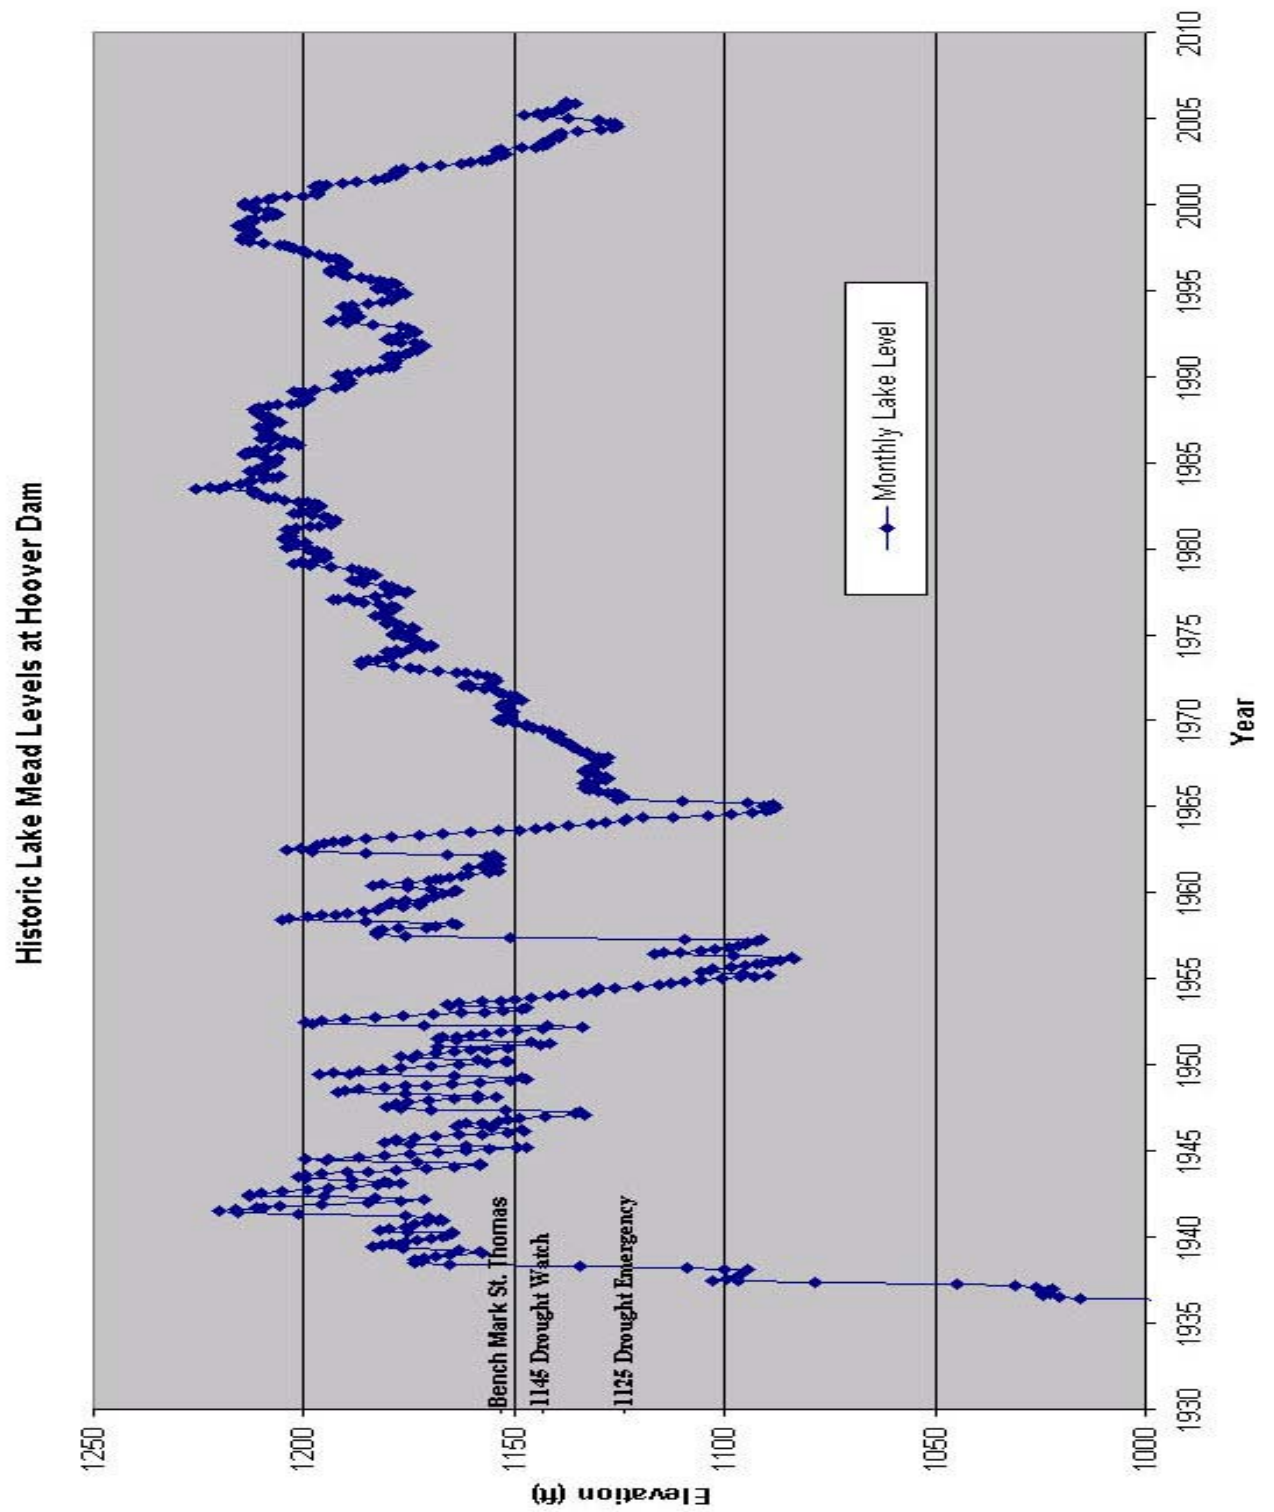
Figure 13: Historic water level fluctuations at Lake Mead.

(Figure 13). Episodes from 1954 to 1957 and 1964 to 1970 remain continuously re-emerged until the reservoir regained its pool level in 1957 and 1970 (Figure 13). In addition to revealing re-emergence episodes, respectively figure 13 also illustrates historic water regulation on the Colorado River. Prior to 1969 annual lake elevations fluctuated dramatically. However since 1969 water levels have remained somewhat static or suggest gradual increases or decreases occurring. This change in fluctuation is attributed to upstream regulation by Glen Canyon Dam that became operational in 1969. However, since 2000 the waters of Lake Mead have receded as a result of increased water usage and decreased snow accumulations. Increased water regulation is not a solution to this problem. Once again in 2003 St. Thomas's structures re-emerged and it is uncertain if or when lake levels will rise to re-submerge St. Thomas.

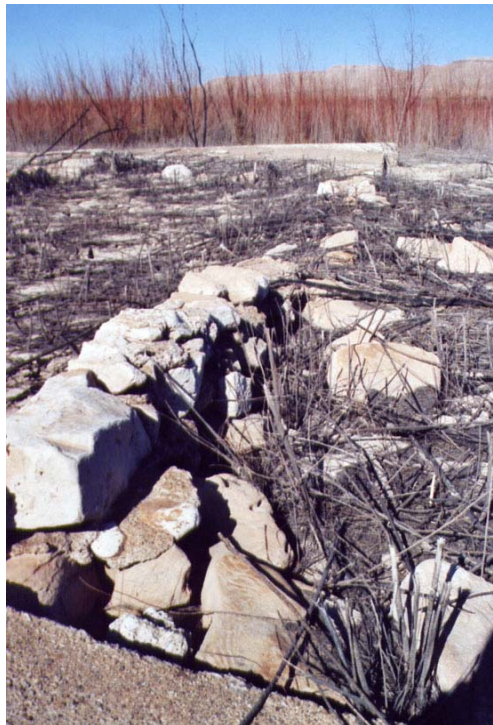
Figure 17: Gentry Store. Photo taken January 2006.

The building structure composition is integral to determine resistance to erosion. Five building materials were utilized at St. Thomas: adobe, wood, brick, sandstone and coarse gravel-aggregate concrete with a thin outer layer of fine textured concrete (Jensen, E. oral communication, January, 2006). Adobe was primarily used during the early stages of the settlement. No adobe or intact wood structures persist at St. Thomas. Brick and stone are the least common materials remaining for those buildings constructed with brick, such as the Gentry Hotel (Figure 14) or St. Thomas Schoolhouse (Figure 15), were disassembled and used in the construction of buildings in Overton, Nevada (Jensen, E. oral communication, January, 2006). Sandstone was used as a secondary building material in the construction of the Gentry Store (Figure 16) (Jensen, E. oral communication, January, 2006). Neither the Gentry Store, nor the Hotel, retains any significant structural walls. Only footings or remnants of foundations remain (Figures 17 and 18).

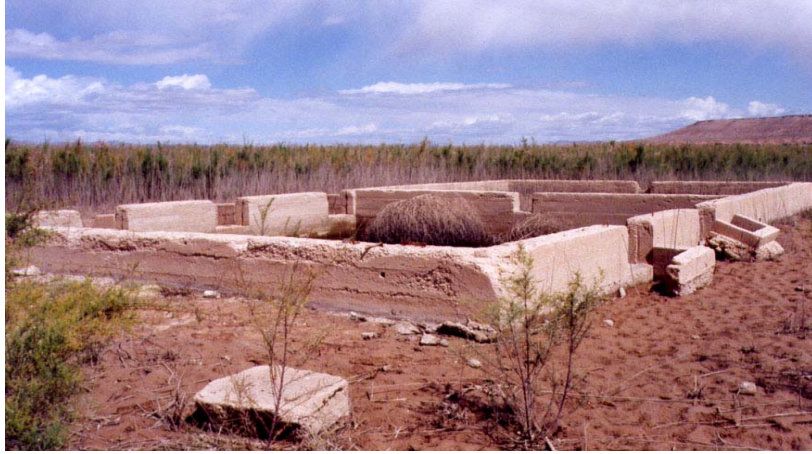
Figure 19: Blacksmith shop. Photo taken May 2005.

The placement of 1 m by 1 m test units was limited to intact walled structures with the minimal presence of *Tamarix ramosissima* and no standing water. The first test unit was excavated within the blacksmith shop (Figure 19). Upon excavation, the unit was located ~100 meters from the shoreline and is in fair condition. The walls are 41cm high and the structure is approximately 8 m by 5 m.

Large-scale erosional activity acting on a structure by structure basis further compromises the structural integrity of the remaining features. Extensive periods of exposure make the remaining structures susceptible to freeze-thaw weathering that causes spalling and cracking (Figure 19). As discovered during XRD analysis of sediment samples, the smectite content of deposited soils corresponds with physical evidence of structural cracking (Figure 39) and foundational warping (Figure 40). Smectites pose a degradational threat to feature stability due to their shrink-swell tendencies, that expand upon contact with rain water or when lake levels rise, and shrink when dryer conditions persist or lake levels decrease. In the long term, smectite expansion and contraction causes cracking and structural instability.

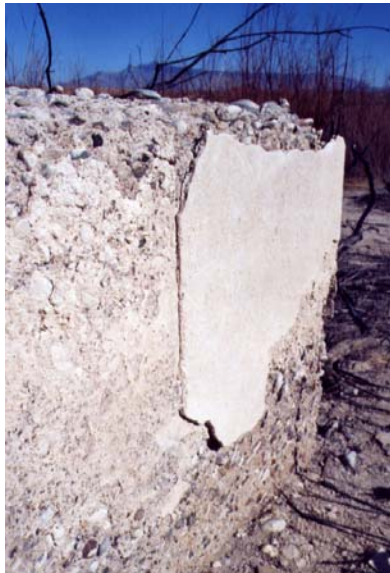
Figure 20: Spalling of concrete on the Gentry House. Photo taken January 2006.

Isolating the variables contributing to the decay of the remaining structures at St. Thomas is difficult because variables often combine and actively work together to produce similar effects. Figure 20 is a typical example of spalling that occurs on the outer layers of concrete on structures. Spalling occurs when the outer layer of concrete weakens and separates from the structure to which it adhered. The typical cause of

spalling at St. Thomas is freeze thaw action, the weakening of the outer layer due to continuous and extreme environmental changes or prolonged forces such as wind or wave action that degrade the resistance strength of the material. The second field session was devoted to deciphering additional erosional mechanisms and processes operating on site.

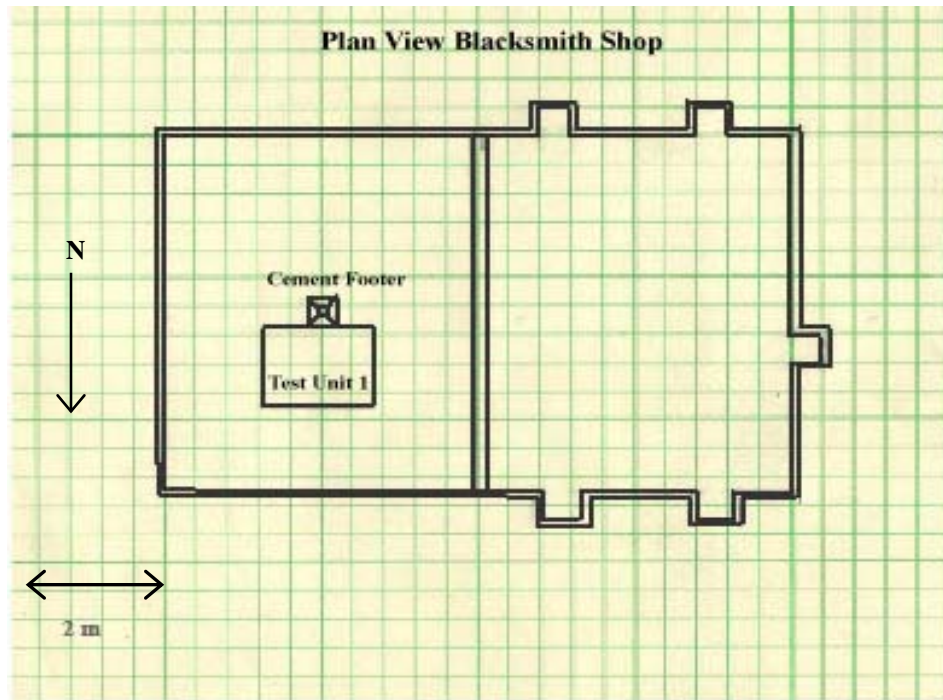
Figure 21: Plan view of the blacksmith shop indicating placement of Test Unit 1.

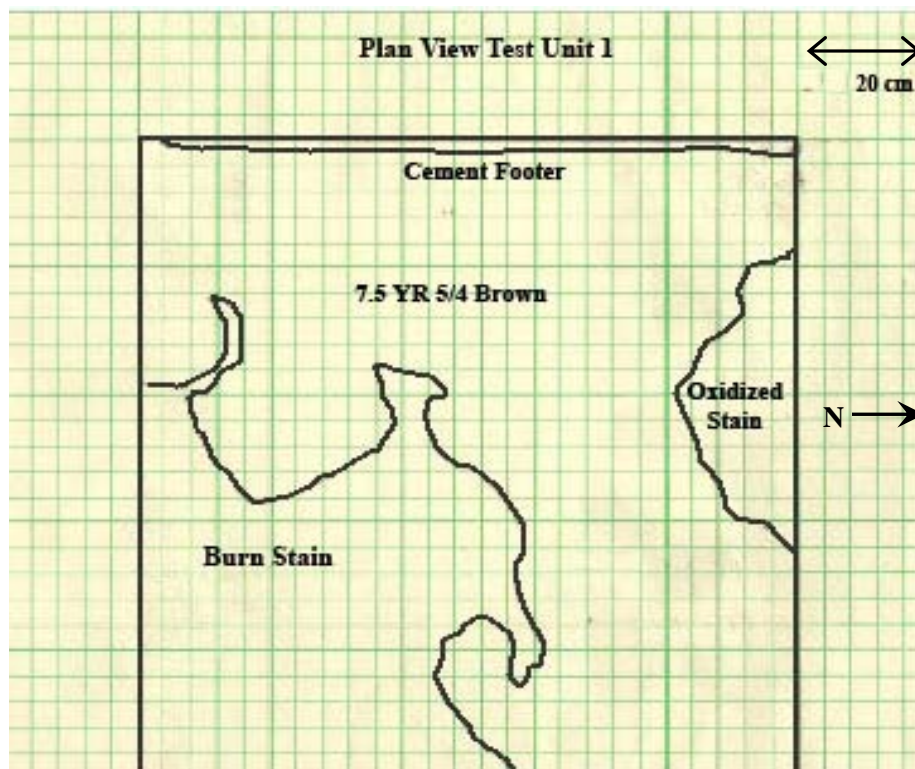
Figure 22: Plan view of Test Unit 1 at terminus of excavation.

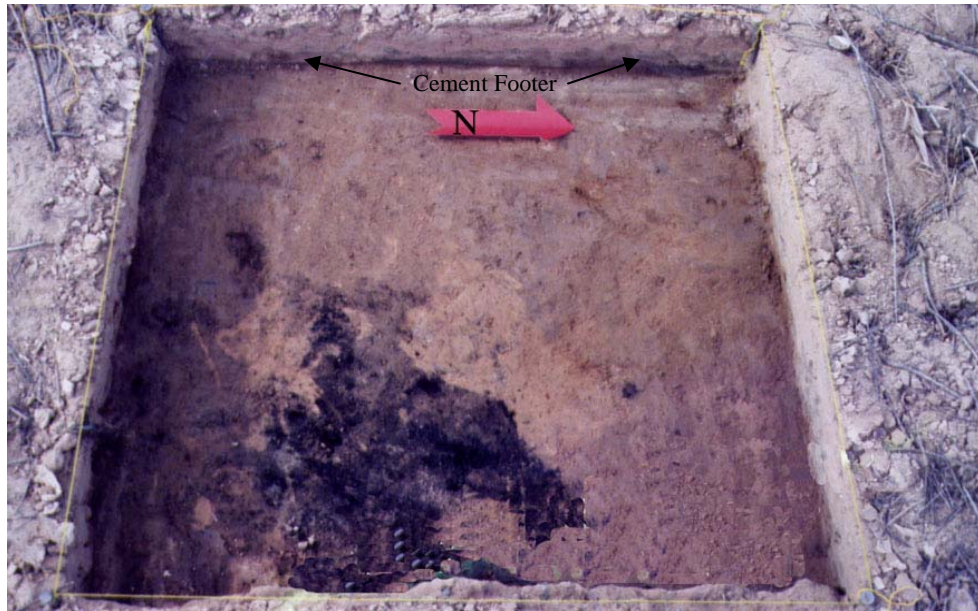
Figure 23: Test unit one terminus of excavation. Note burn stain in lower left, oxidized stain to the right center and cement footer slightly protruding from the west wall. Photo taken January 2006.

The stratum below the C was identified as brown (7.5yr 5/4), silty medium-grained sand. This stratum retained considerable moisture and was sterile of cultural material and Asiatic clams (*Corbicula fluminea*). Excavating this stratum unearthed the cement footer of a center support structure, a burn stain in the eastern portion of the unit and an oxidized stain in the northern portion of the unit (Figures 22 and 23). The burn could be evidence of the tendency for citizens of St. Thomas to burn their residences at departure, to show their disdain for having been forcibly evicted from their homes and property. A considerable amount of oxidized metal fragments and nails were found throughout the upper C stratum and possibly leached into the lower A stratum, causing the stain. No metal was found in the A stratum. Due to the absence of artifacts, compactness of the soil, and the location of the cement footer, this horizon is thought to constitute the original A horizon of the settlement soil. Excavation continued 5 cm into the stratum, which was determined to constitute the original settlement soil.

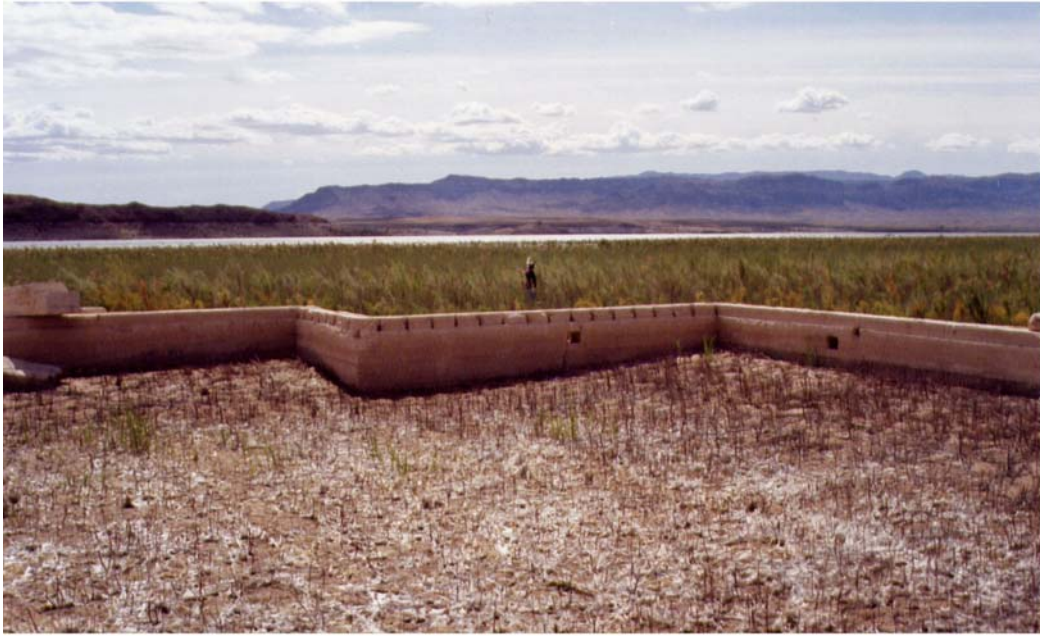
Figure 24: Portion of the foundation of the St. Thomas Schoolhouse, looking southwest toward Lake Mead. Note concave distribution of sediment from the center of the photo to the walls. The person in the foreground marks the standing water boundary. Photo taken May 2005.

Placement of this test unit was used to deduce if erosional and depositional activities occurred within larger structures. The plan view inspection of the sediments within the interior of the schoolhouse indicates a concave build up of sediments near the exterior east and west walls, shallowing in the center suggests that wind-wave action has caused uneven deposition (Figure 24).

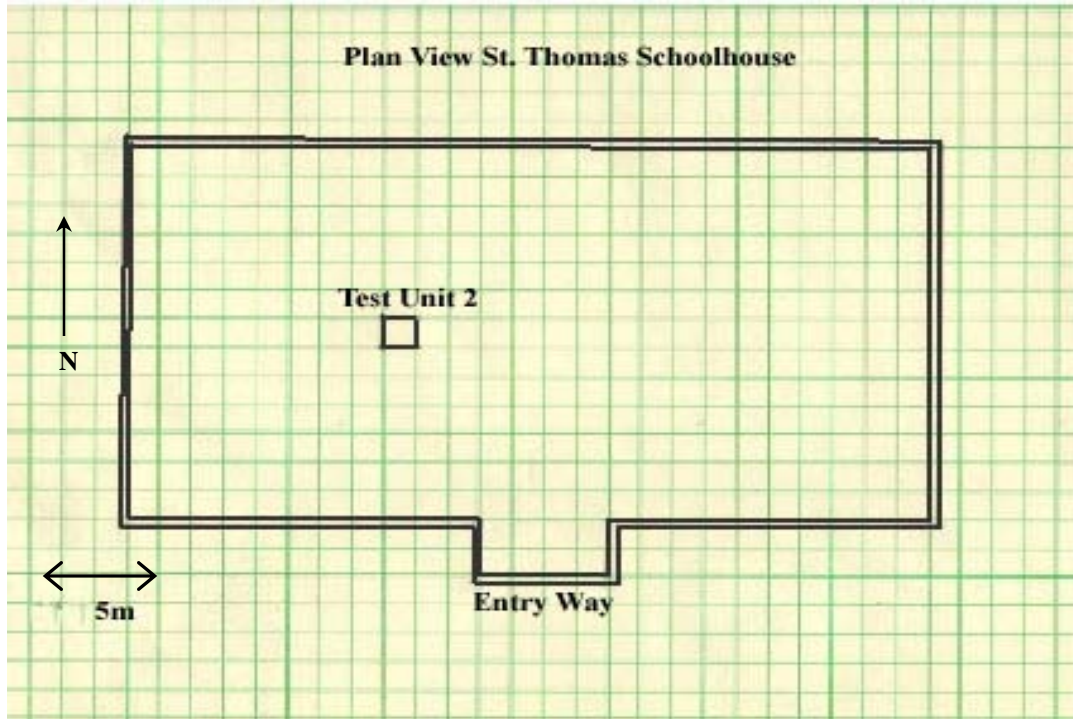
Figure 25: Plan of St. Thomas Schoolhouse indicating approximate location of Test Unit 2.

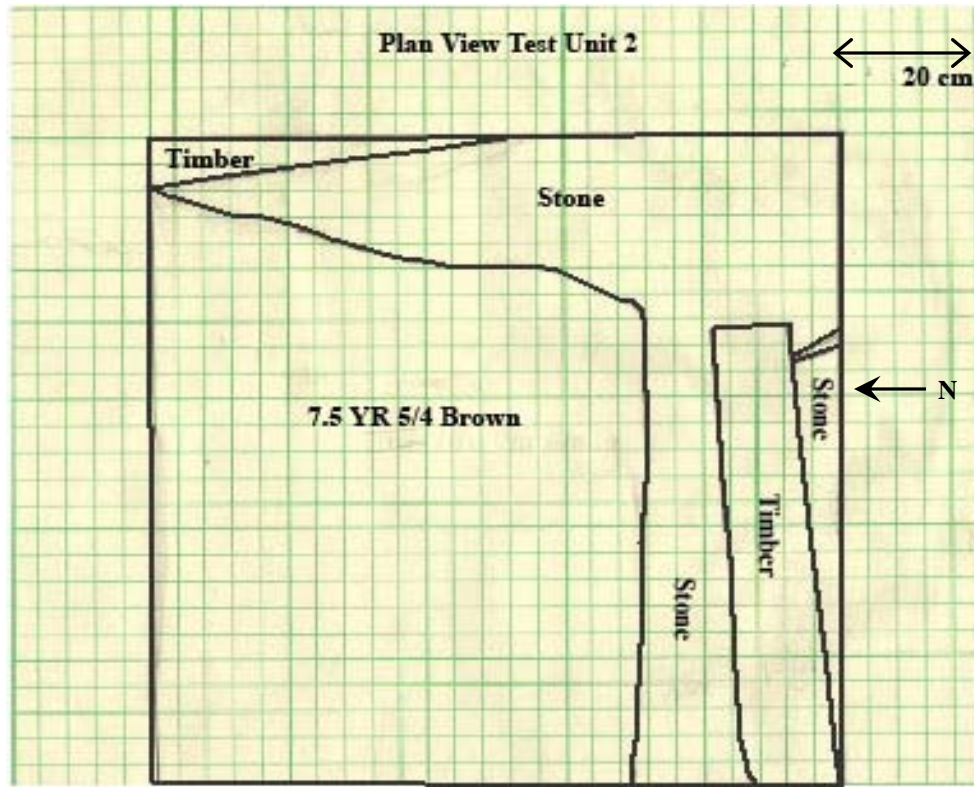
Figure 26: Plan view of Test Unit 2 at terminus of excavation.

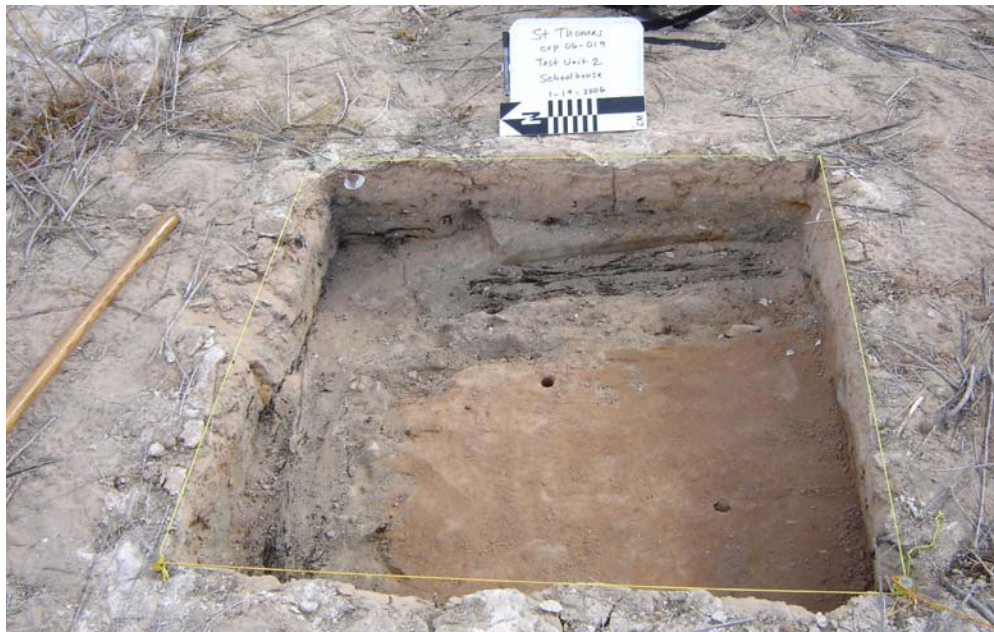
Figure 27: Test unit two at terminus of excavation. Note brown color in southwest portion, and light grey sediments with timbers and concrete structure in the remainder of the unit; the light grey sediments are artificial fill. Photo taken January 2006.

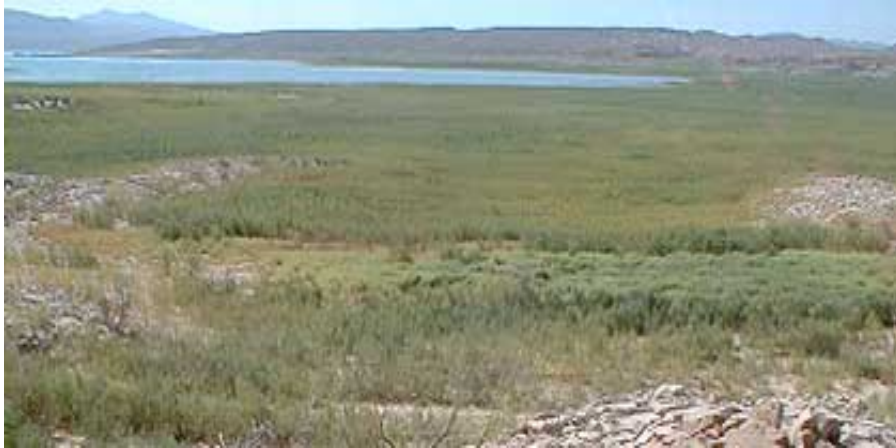
Figure 28: St. Thomas Point overlooking re-emerged area. Note abundant tamarisk growth. Photo taken May 2006.

The survey during the January field session was more productive than the previous session conducted in May for visibility was less obstructed due to the leaf-off status of the tamarisk (Figures 28 and 29). However, as visible in figures 28 and 29, the dense tamarisk made it difficult or impossible to conduct survey or visual inspection of many areas within the study site.

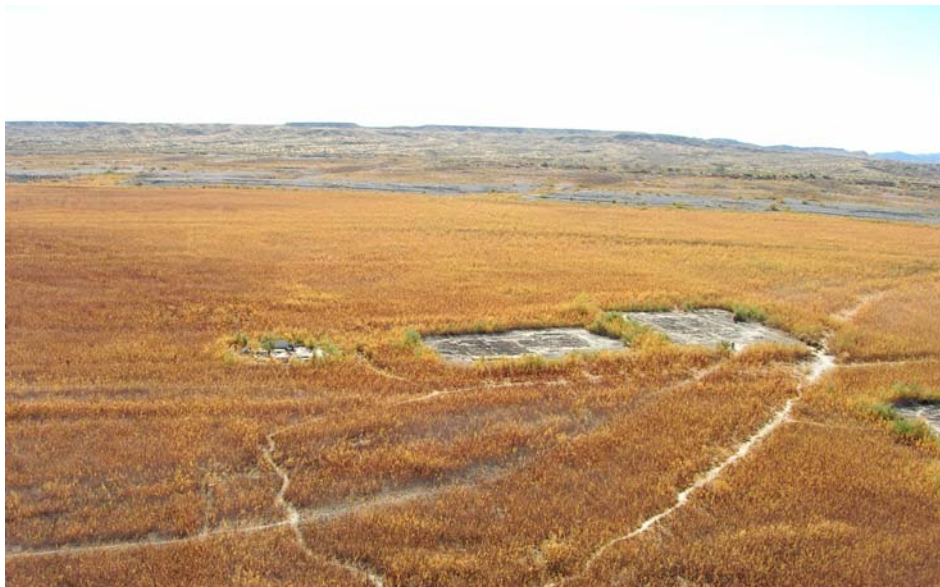
Figure 29: Aerial photo taken during Tamarisk leaf-off. Note abundance of tamarisk and burn areas around remaining structures. Photo source: Lake Mead NRA, January 2003.

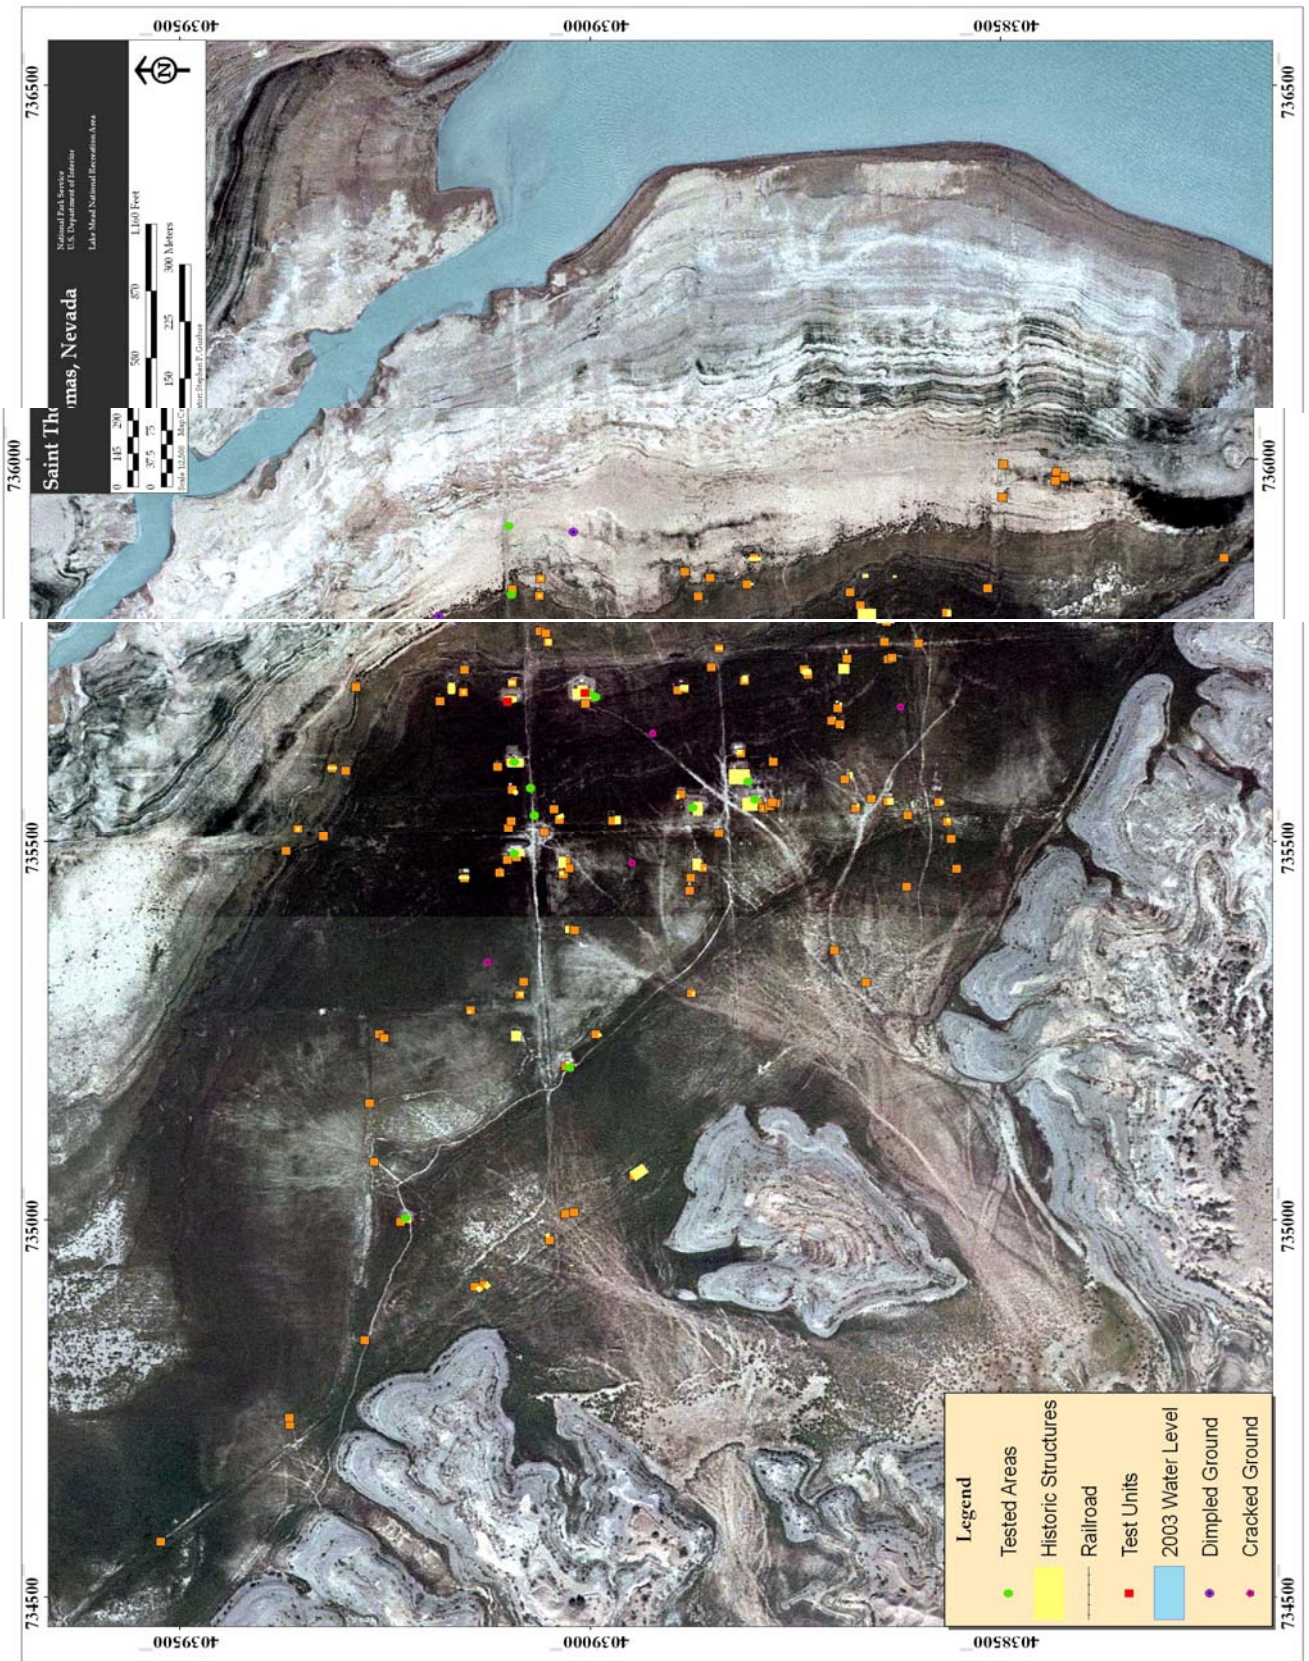
Figure 30: Site map of St. Thomas depicting exposed cultural features, tested areas, excavated test units and ground patterns. Map modified from Gushu, 2005.

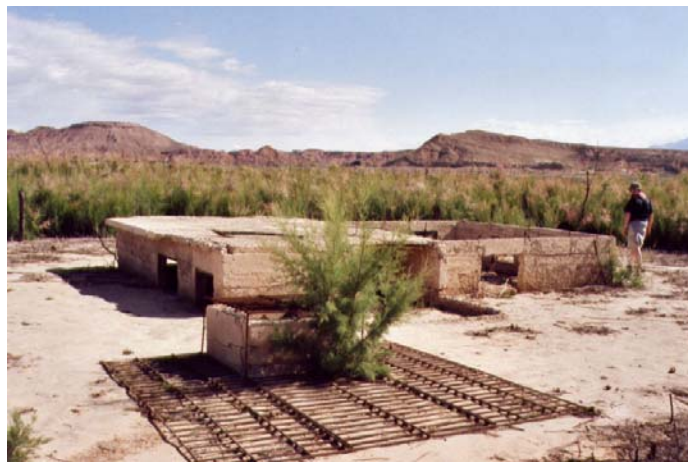
Figure 31: Two level home where deposits are > 63 cm. Photo taken May 2005.

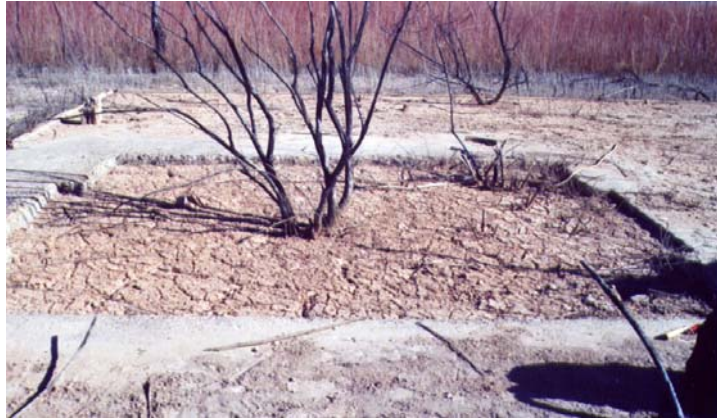
Figure 32: Oil changing pit where deposits are  $>63$  cm. Photo taken January 2006.

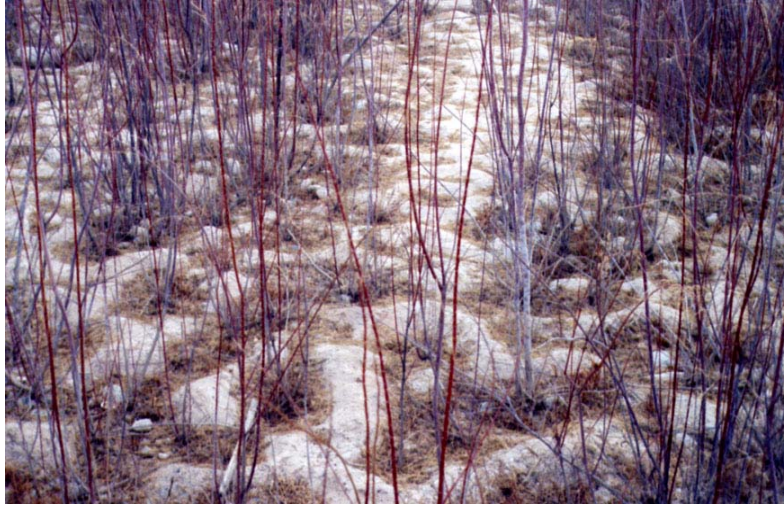
Figure 33: Dimpled pattern observed in the foreshore region. Note tamarisk emerging from center of the dimpled feature. Photo taken January 2006

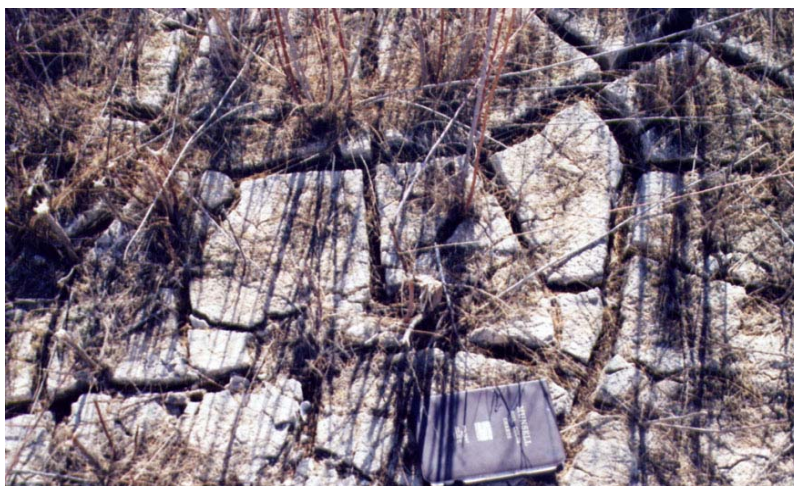
Figure 34: Cracked ground observed further backshore. Mud plates are ~5cm thick. Photo taken January 2006.

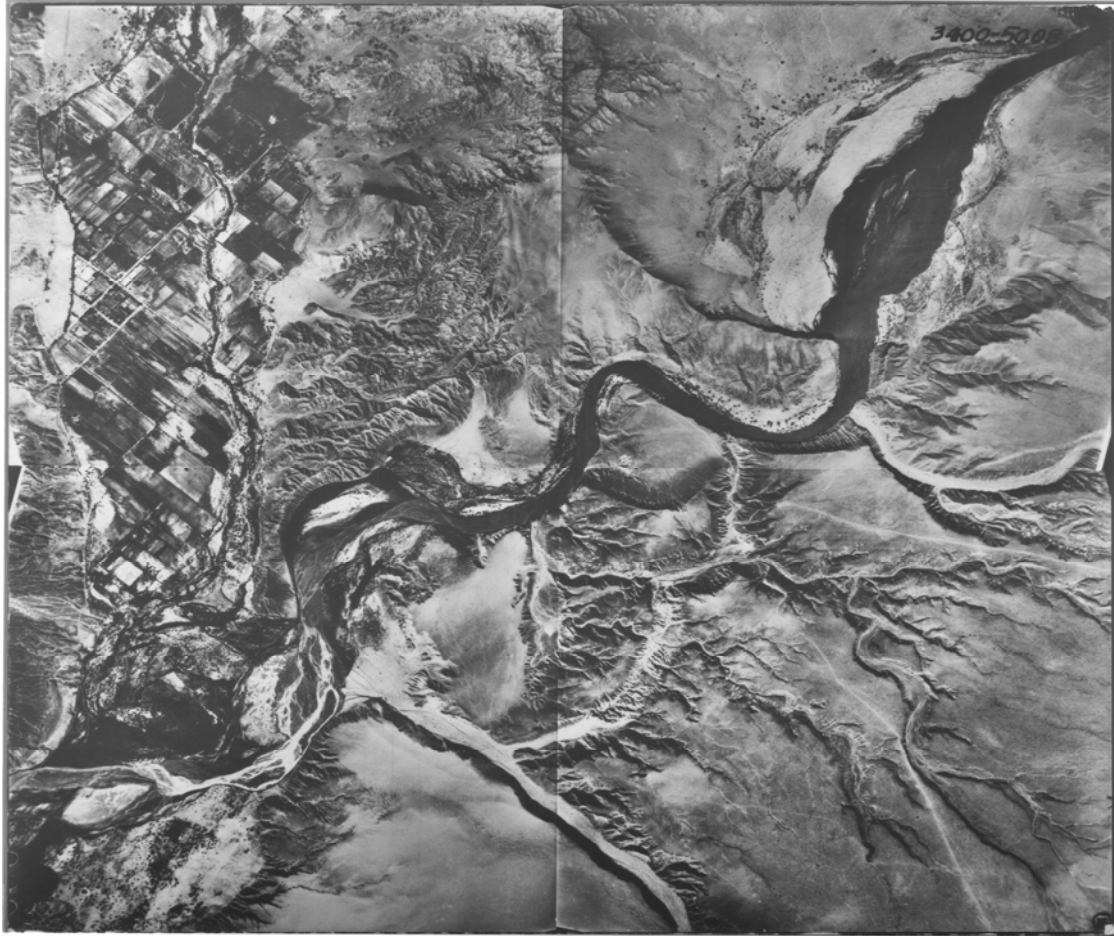
Figure 35: Aerial photo acquired in 1925 by the Fairchild Corporation prior to submersion of St. Thomas and surrounding area. Note agriculture in the upper and central left portion of the image. The Virgin River is flowing from the upper right corner to the southwest and the Muddy River from the upper left to the south. Photo source: Whitter College Fairchild Collection Whitter, California.

At the beginning of this research it was hypothesized that the origin of depositional sediments at St. Thomas derived from turbidity currents of one or a combination of three river sources: Muddy, Virgin or Colorado rivers. Eight specific stereoscopic aerial images found at Whittier College's Fairchild Collection proved valuable in assessing St. Thomas's pre-inundation land-use patterns. These images confirm written documentation describing the intensive agricultural practiced at St. Thomas prior to inundation (Figure 35).

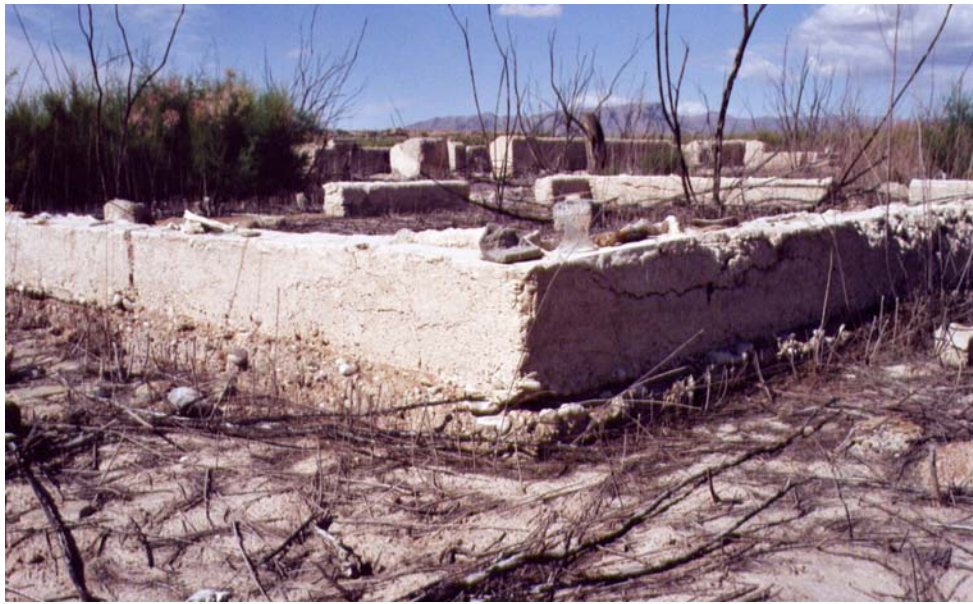
Figure 36: Gentry garage. Note cracks in walls where tamarisk have penetrated. Photo taken May 2005.
